# MONUMENT RECORD

Corner ID: **BeBI\_H07**

**Sixteenth Corner**

Section 8-T10N-R02W, 2nd P.M.

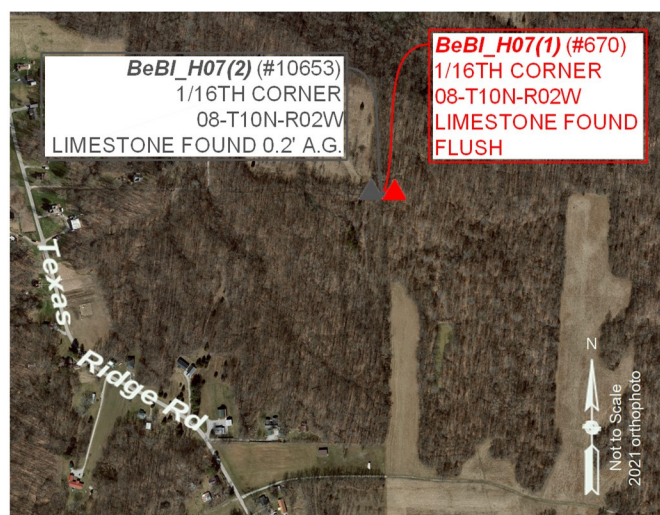
## MONUMENT LOCATION SKETCH:

2 stones were found at this sixteenth Section corner. (#670) herein referred to as BeBI\_H07(1) is the monument accepted this survey, because I believe it to have been set in the first subdivision of the Section by M.H. Buskirk on March 6, 1884, documented in Legal survey book 2, page 399, is a 0.4' north-south by 0.9' east-west limestone with an east-west groove across its top, found flush with ground, on the North side of an old east-west roadbed. It appears remnants of an ancient South bound fence line lines up with this stone. (#10653) herein referred to as BeBI\_H07(2) because I believe it to have been set in a subsequent subdivision of the Section by Charles M. Bowers, Deputy of the Monroe County Surveyor on April 26, 1915, documented in Legal survey book 3, page 52, is a 0.5' north-south by 0.6' east-west Limestone found with its west edge (which is slightly higher than its east edge) 0.2' above ground, in the center of an old east-west roadbed. We cut a cross on top of the stone and set a 5/8" rebar with Monroe County witness point cap on top, against the stones North edge, flush with ground. An old North bound fence line lines up with this stone.

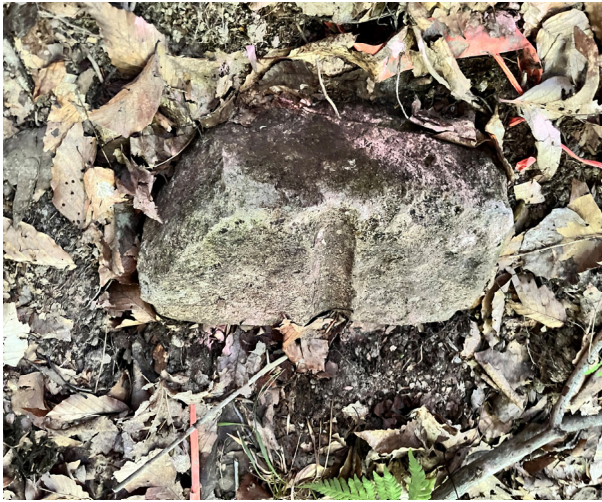
*Photo Orientation & Description:* BeBl\_H07(1) from above

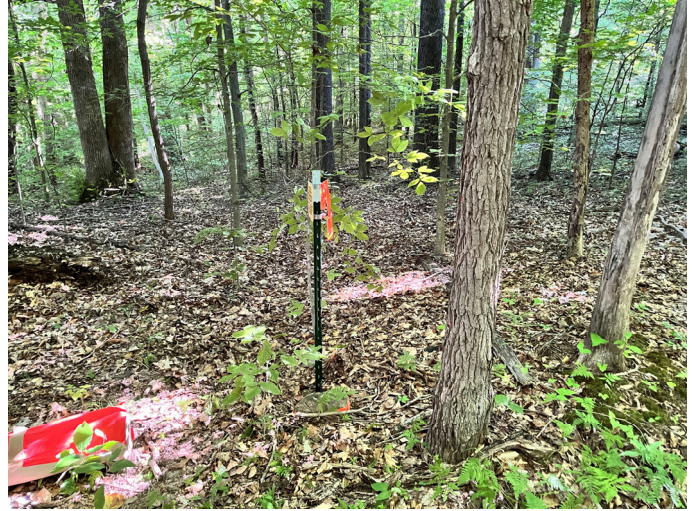
*Photo Orientation & Description:* BeBl\_H07(1) from South Looking North

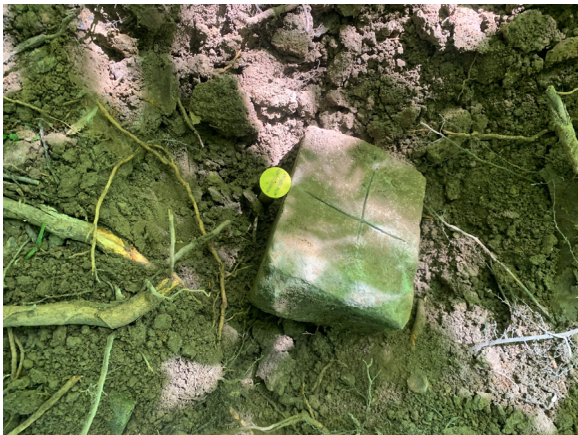
*Photo Orientation & Description:* BeBl\_H07(2) from above.

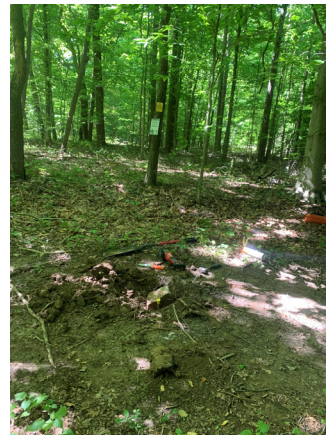
*Photo Orientation & Description:* BeBl\_H07(2) from Northeast looking Southwest.
